**Re: GE-Pittsfield/Housatonic River Site  
Silver Lake Area (GECD600)  
2018 Annual Monitoring Report**

# 2018 ANNUAL MONITORING REPORT

Silver Lake Area

February 2019

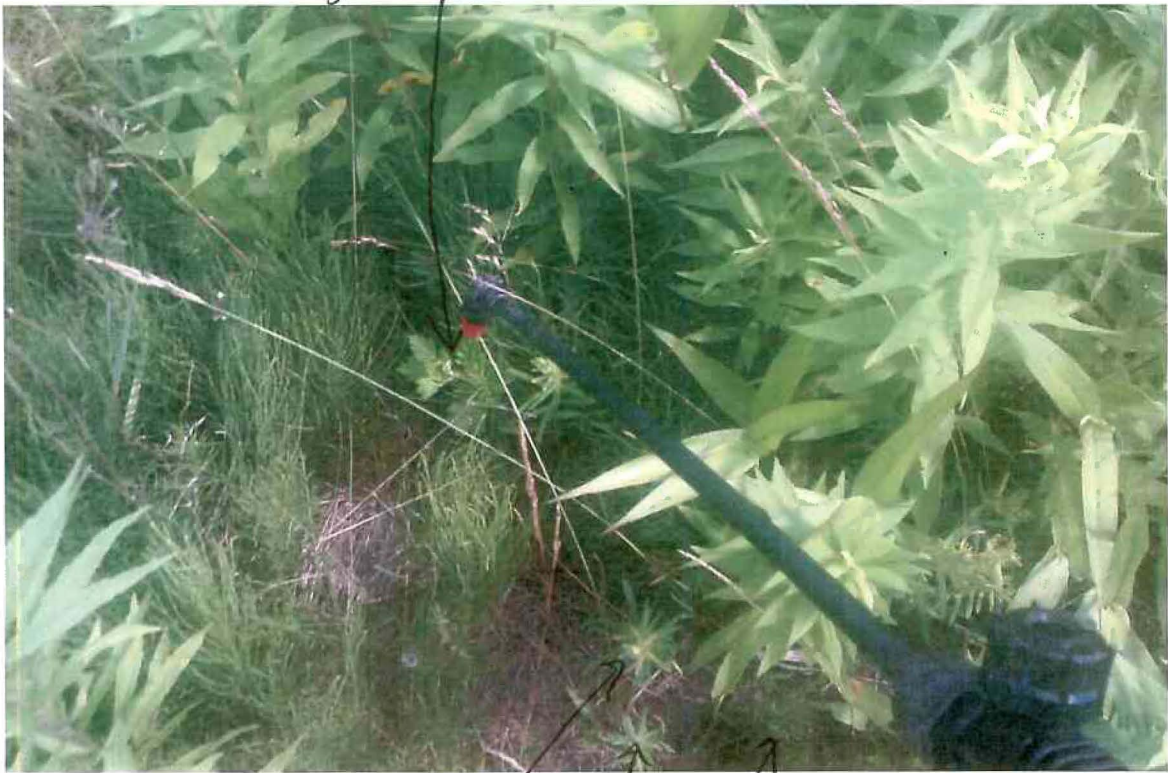
Mugwort seedlings

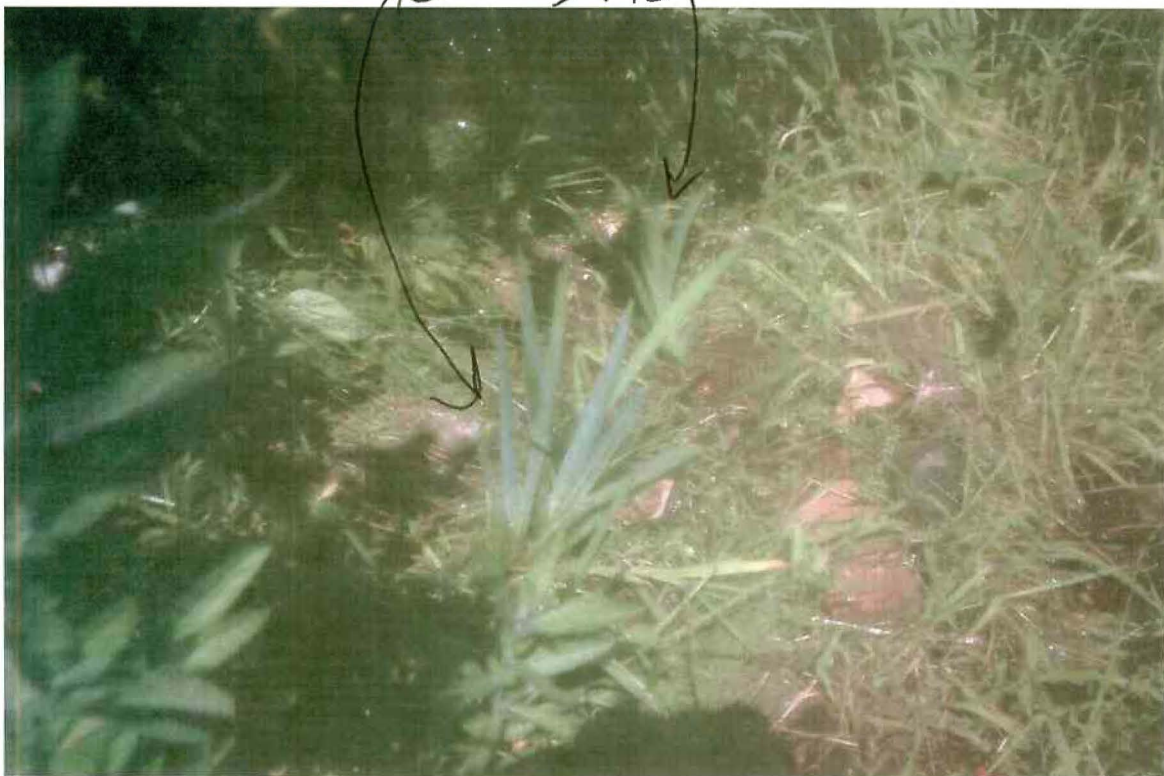
Cypress Spurge

Yellow Iris

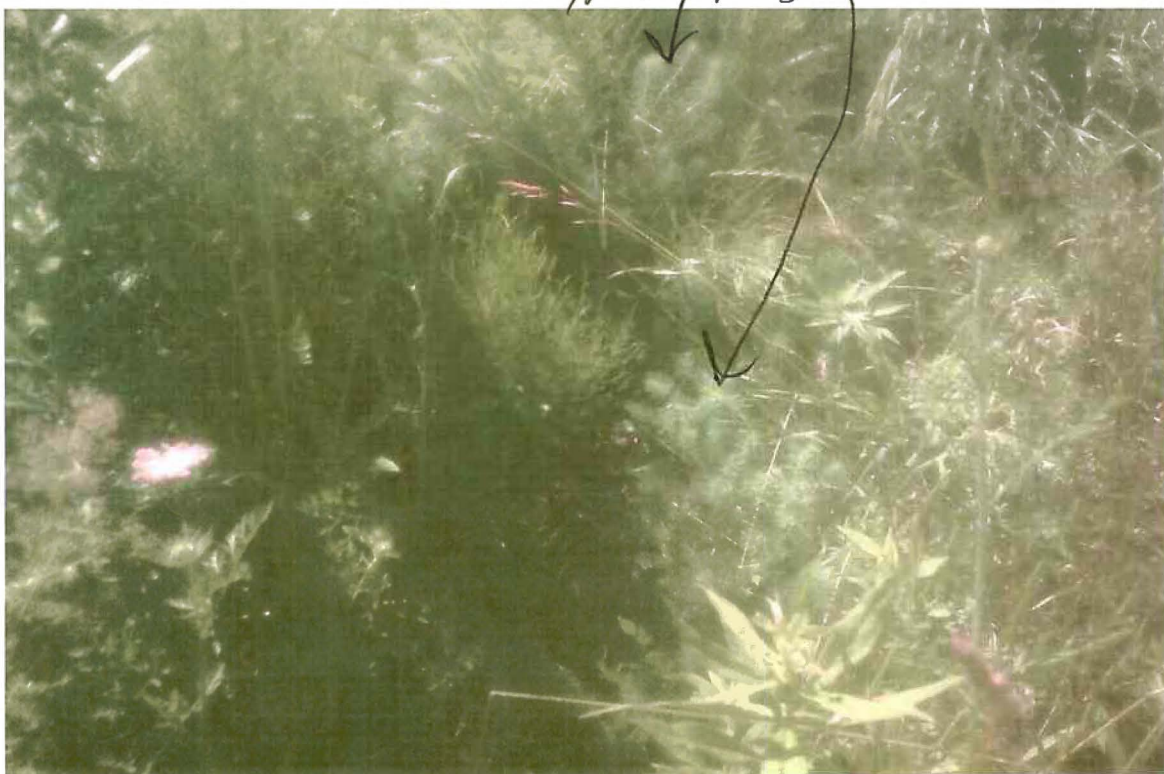
Cypress Spurge

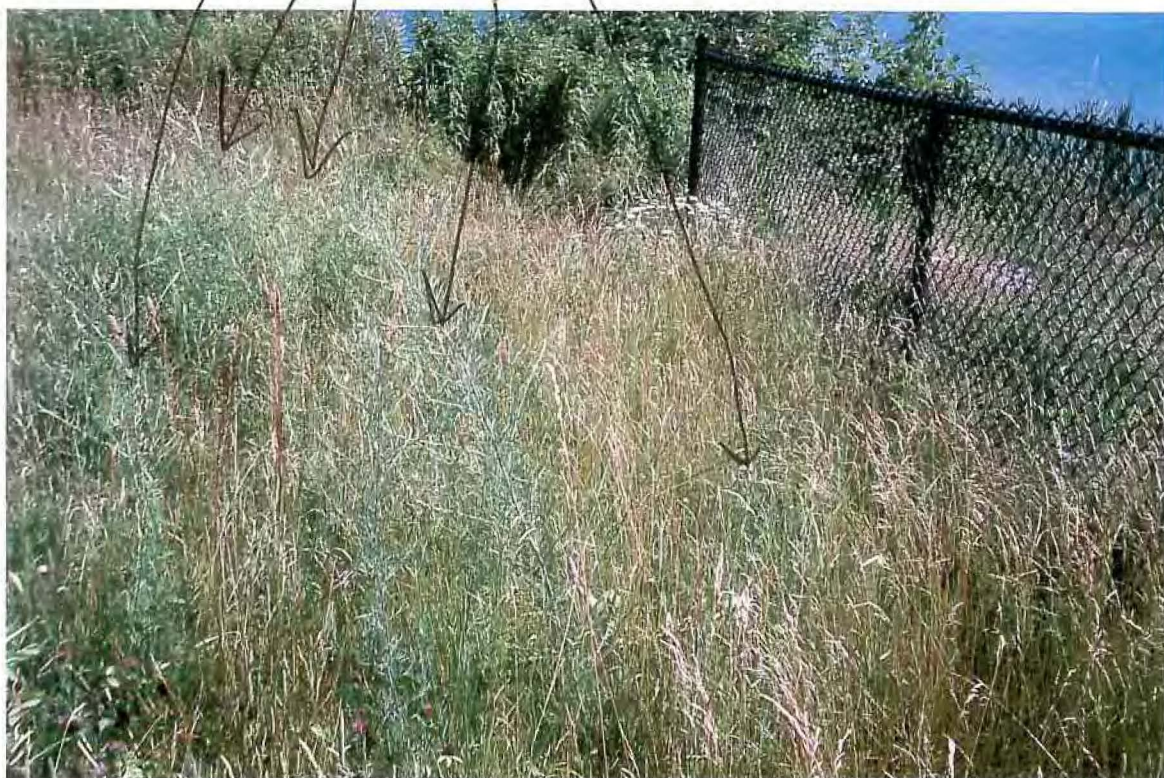
Spotted Knapweed

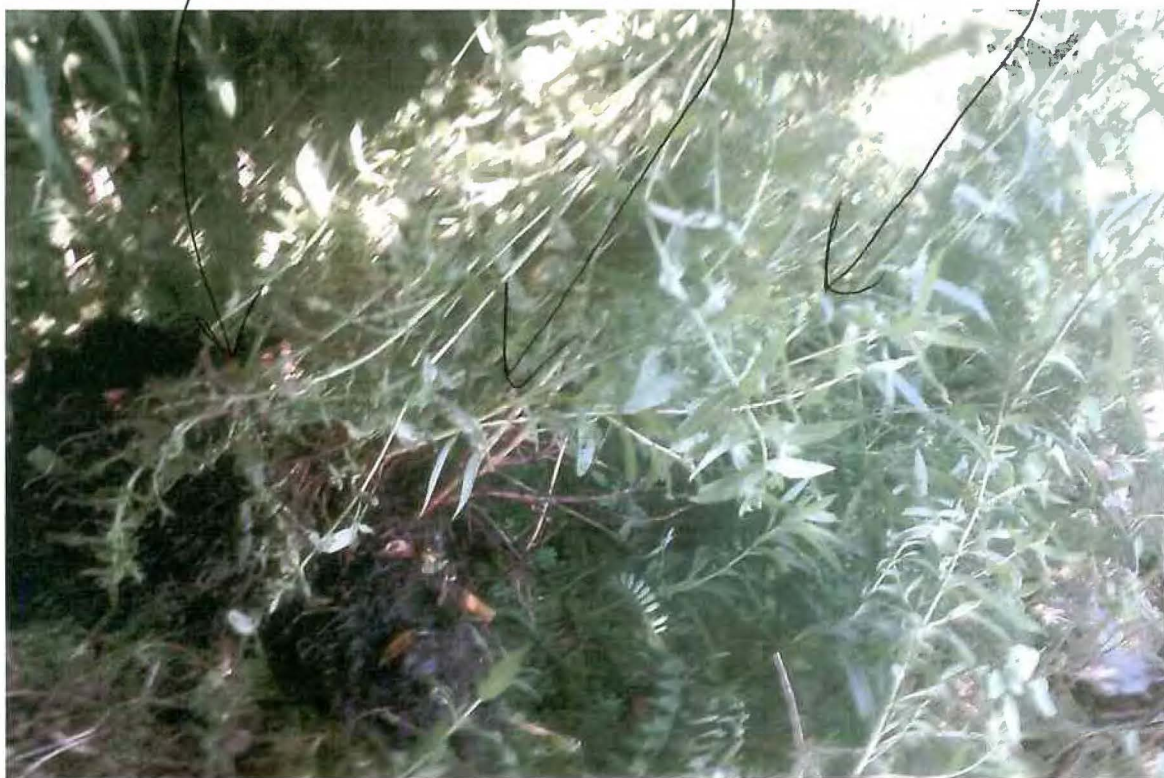
PURPLE LOOSESTRIPE REMOVED

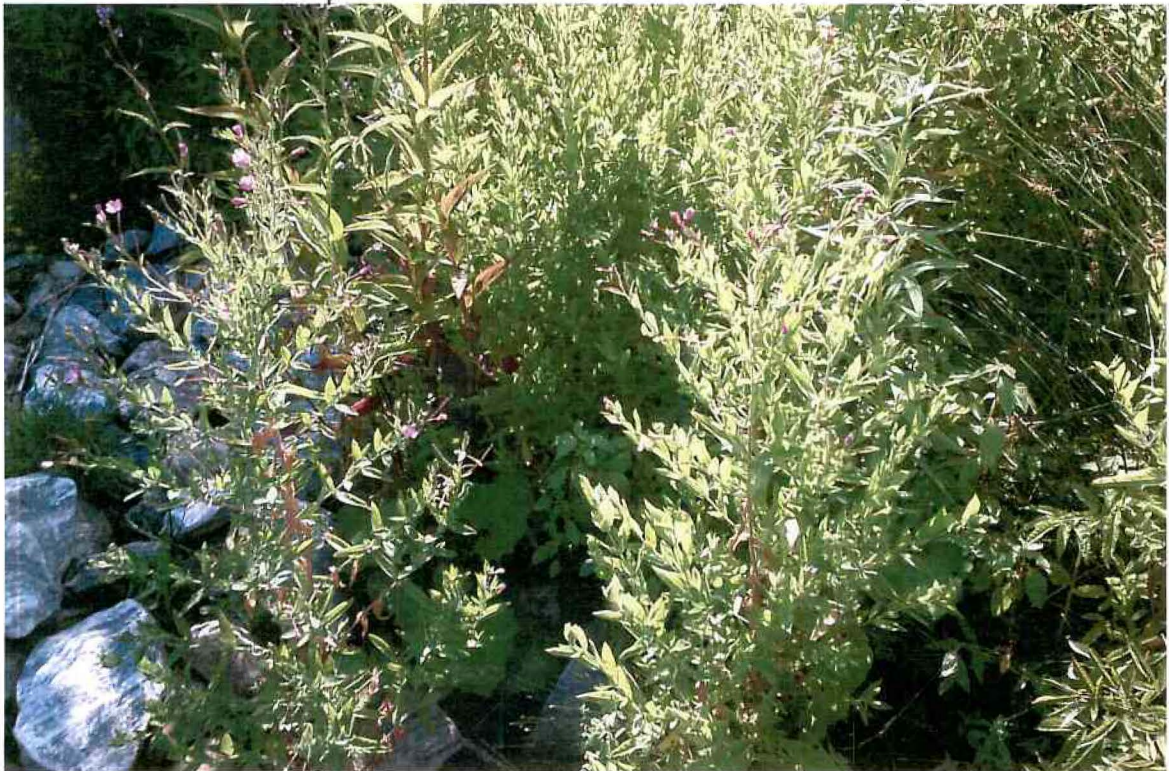
PURPLE LOOSESTRIFE

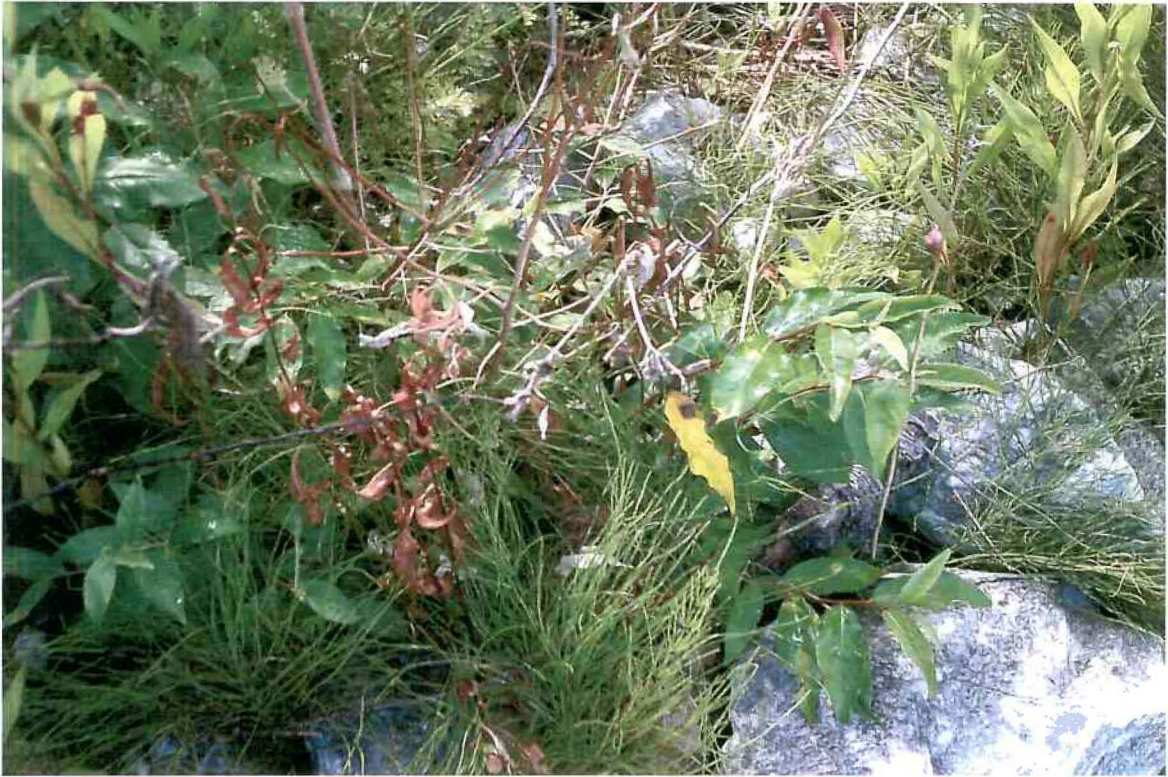
RUSSIAN OLIVE still trying to live

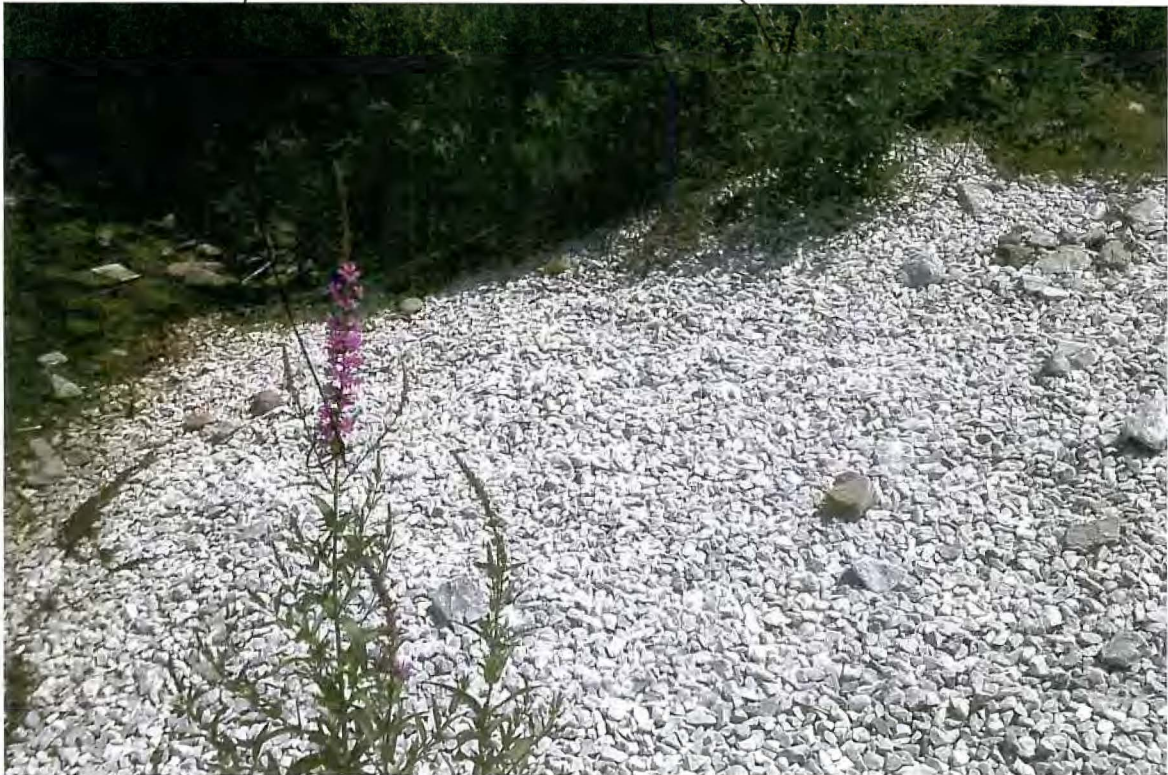
1 Purple Loosestrife

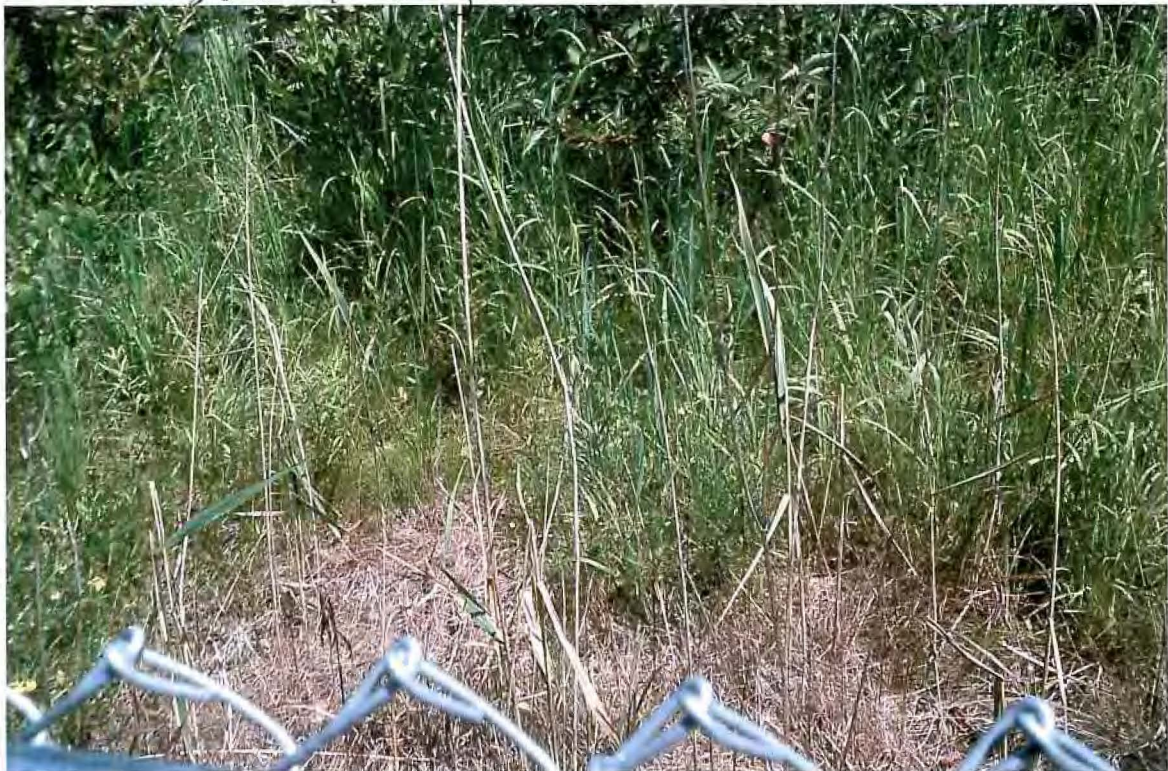
Dead Phragmites

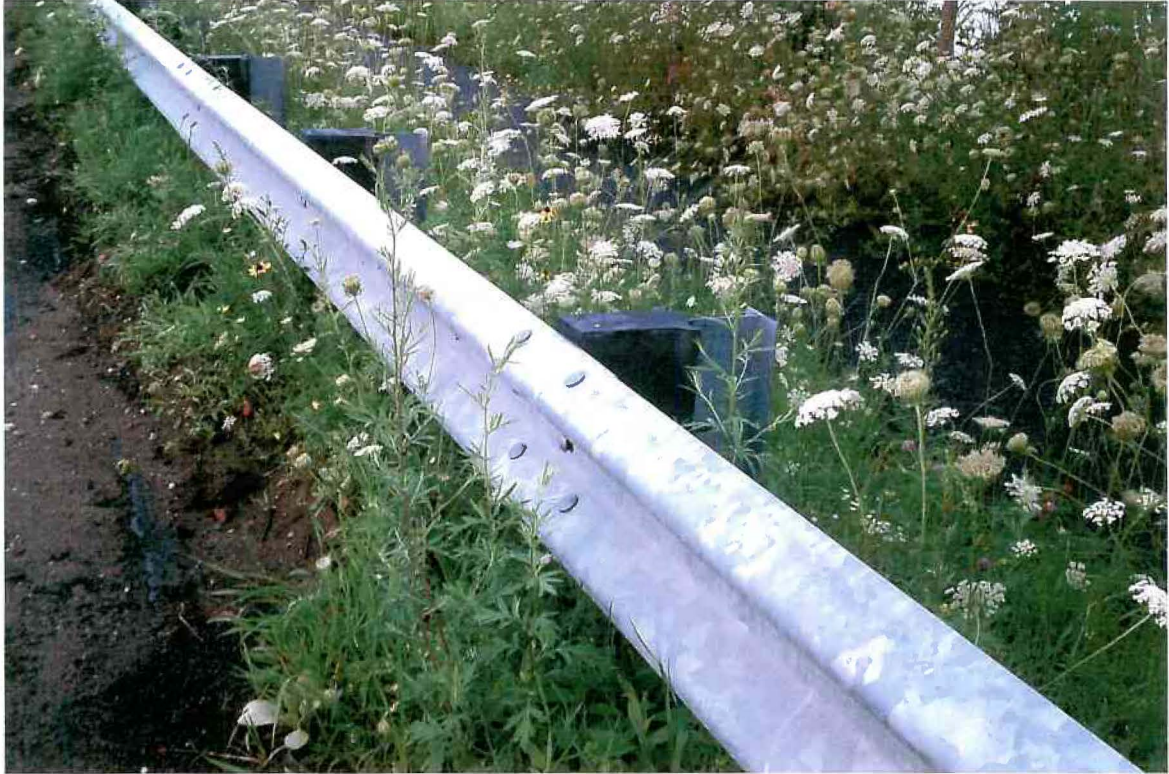
Mugwort

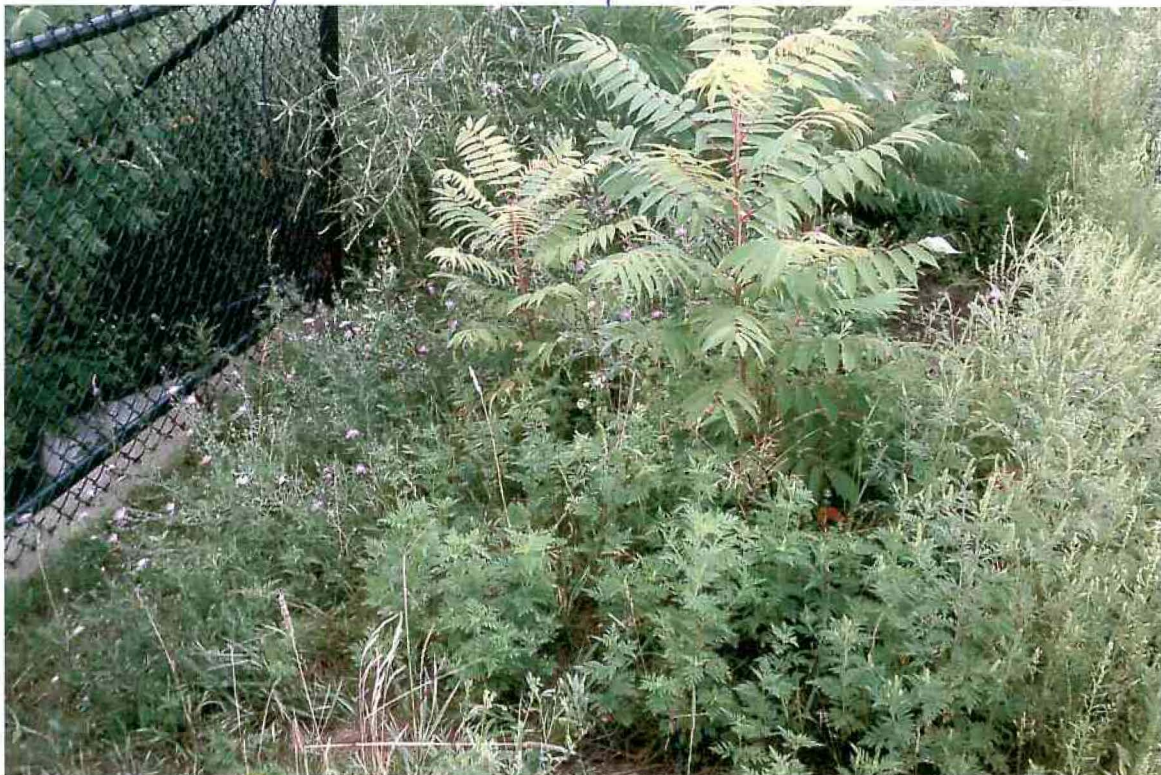
Spotted knapweed patch

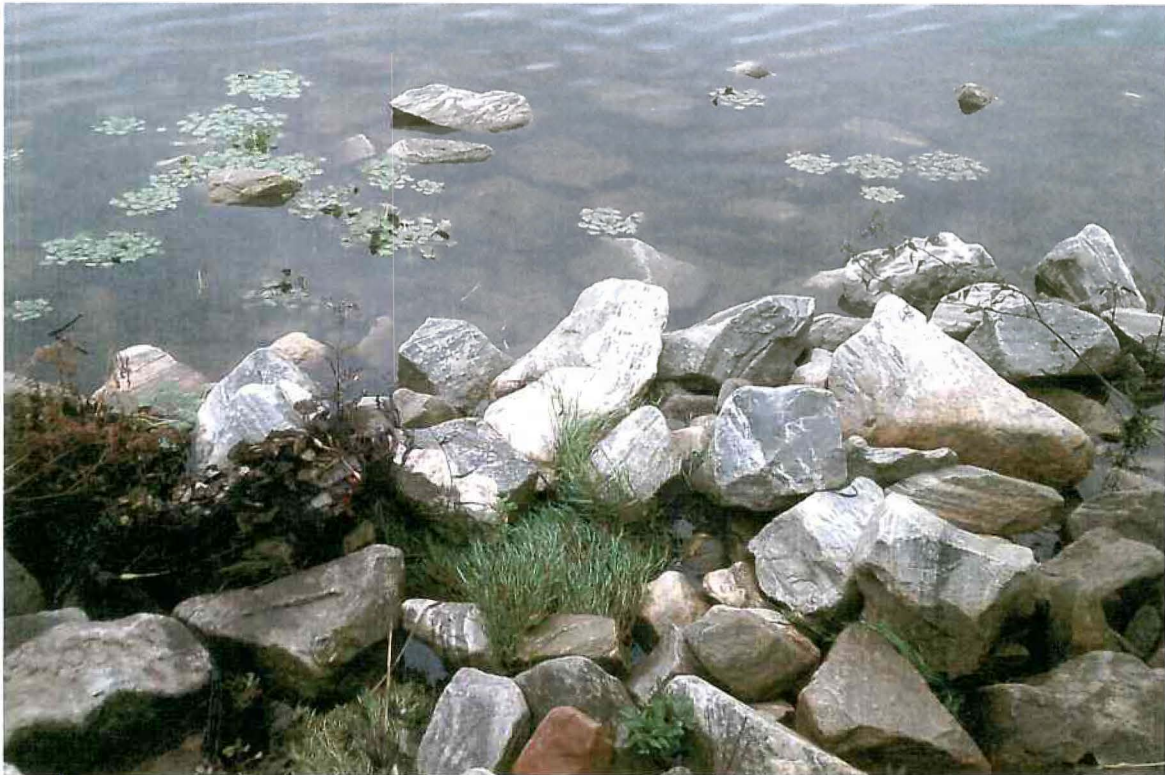
Water chestnuts invading

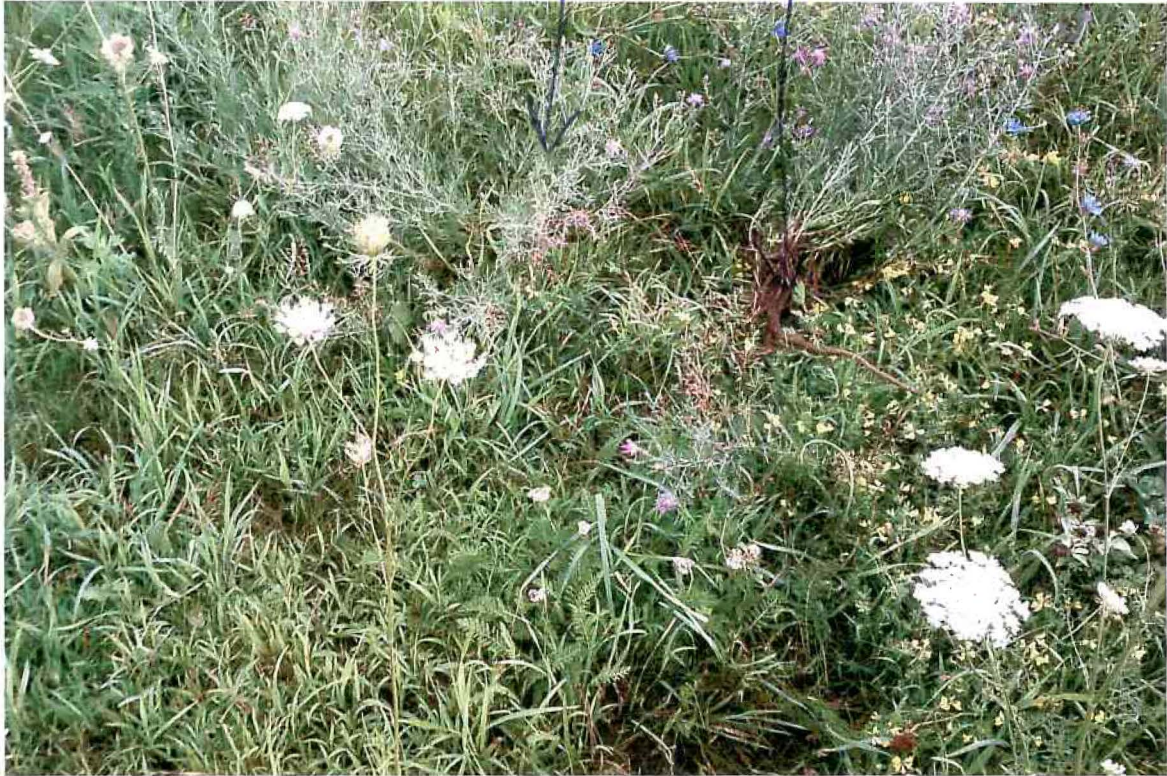
Spotted knapweed

Large taproot  
removed

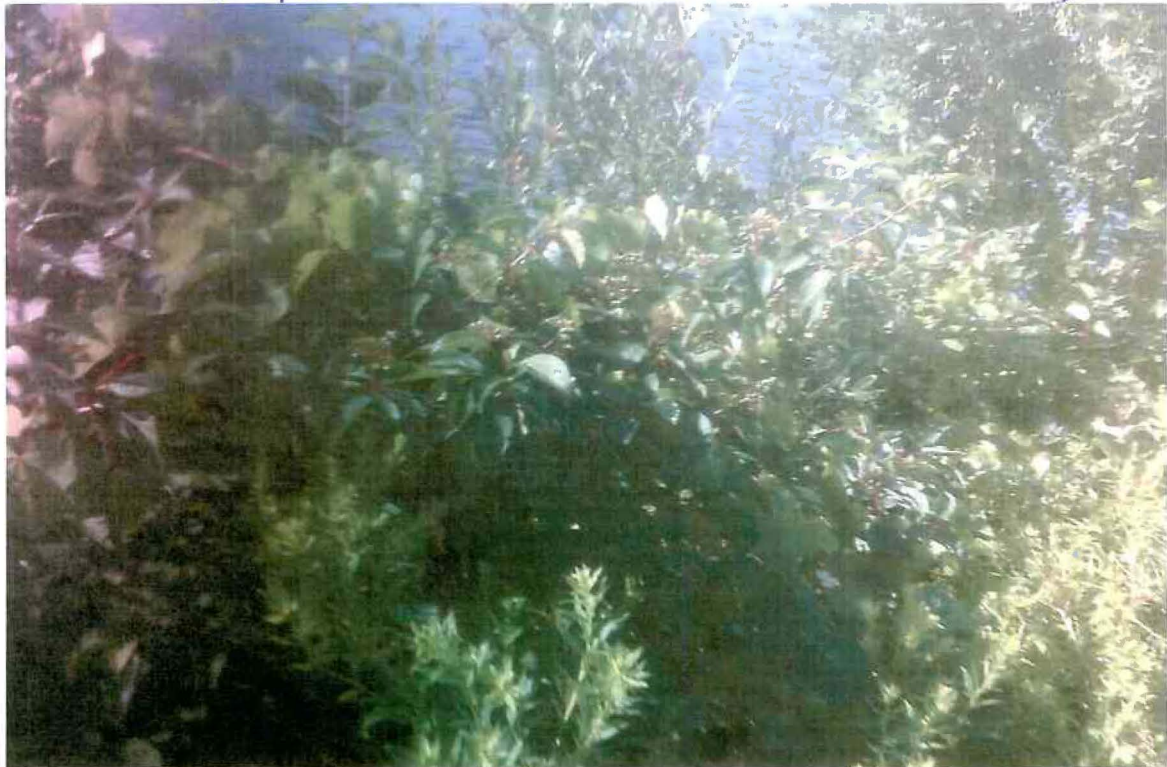
Grapevine severed and removed from Dogwood

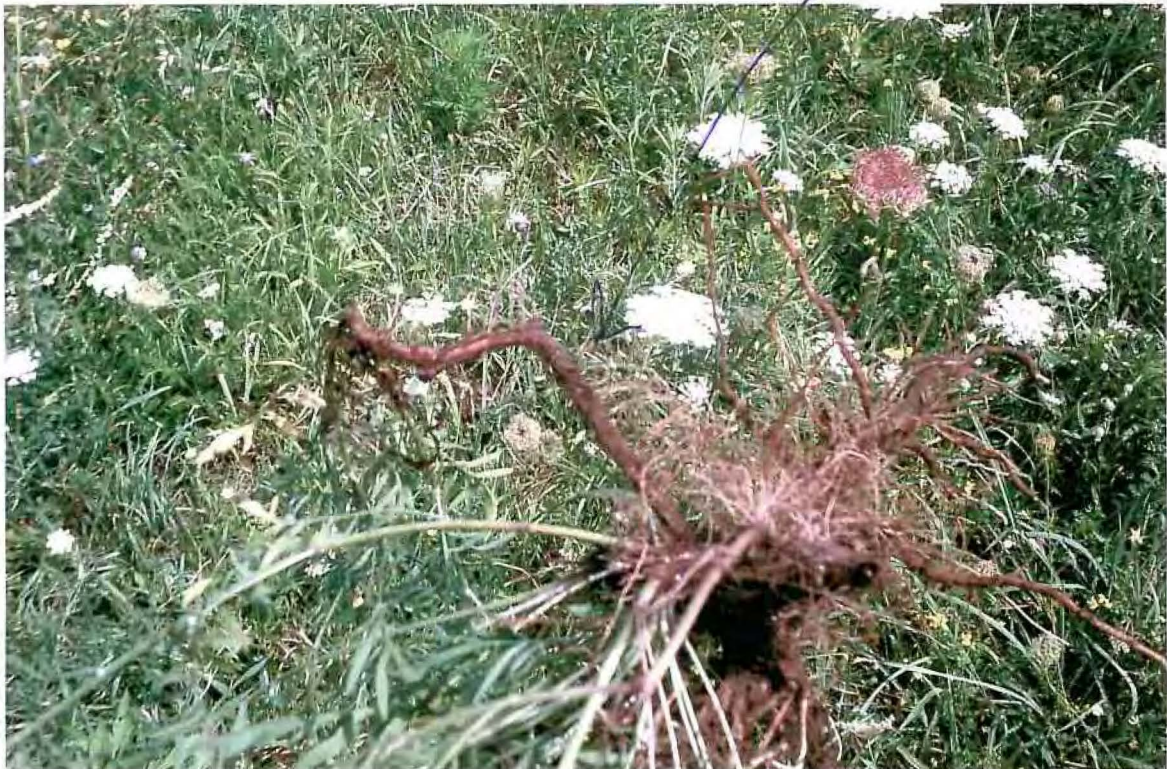
Large Spotted Knapweed root Large

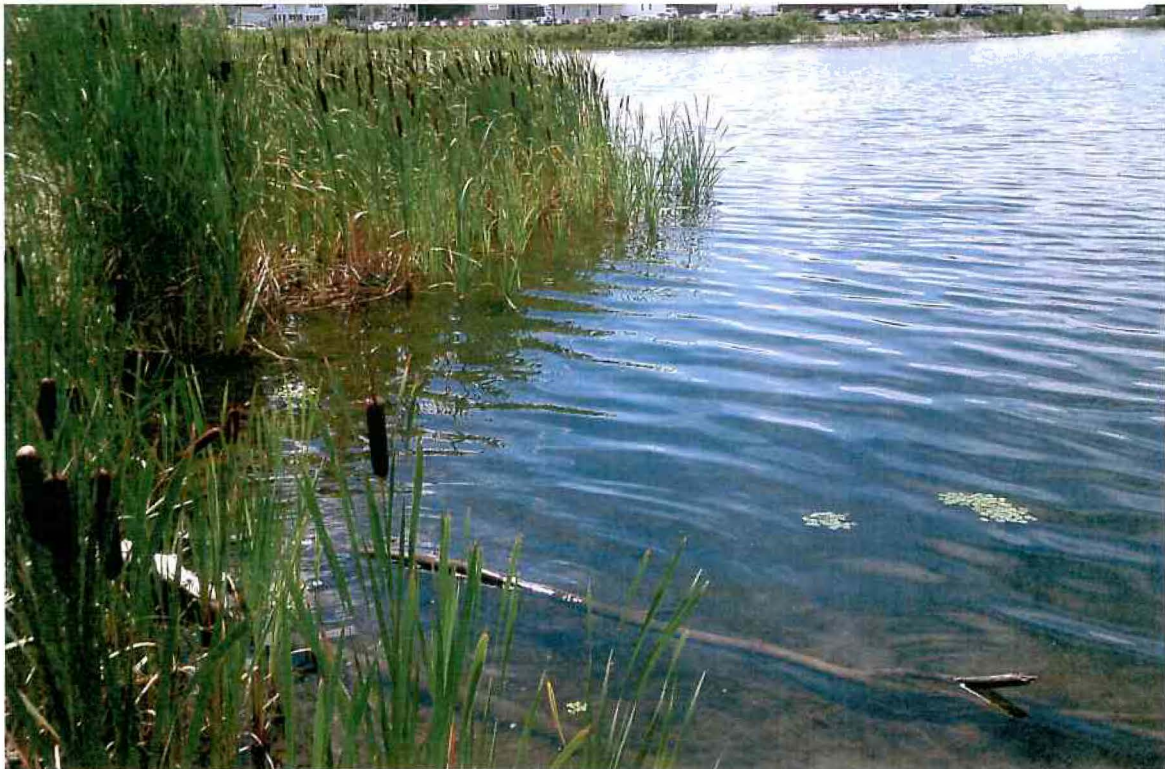
Water chestnut plants found invading Silver Lake through large drain pipe from adjacent pond across Silver Lake Blvd.

Water Chestnut

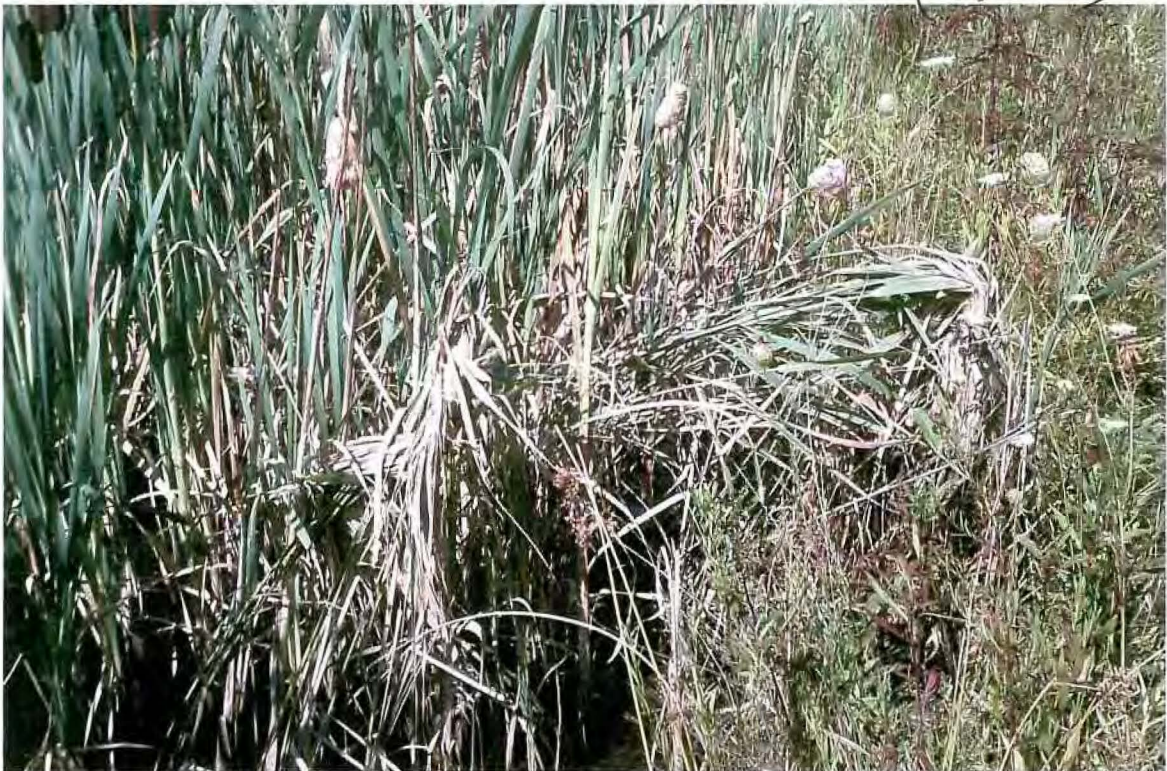
PHRAGS Treated 5<sup>th</sup> treatment (DEAD)

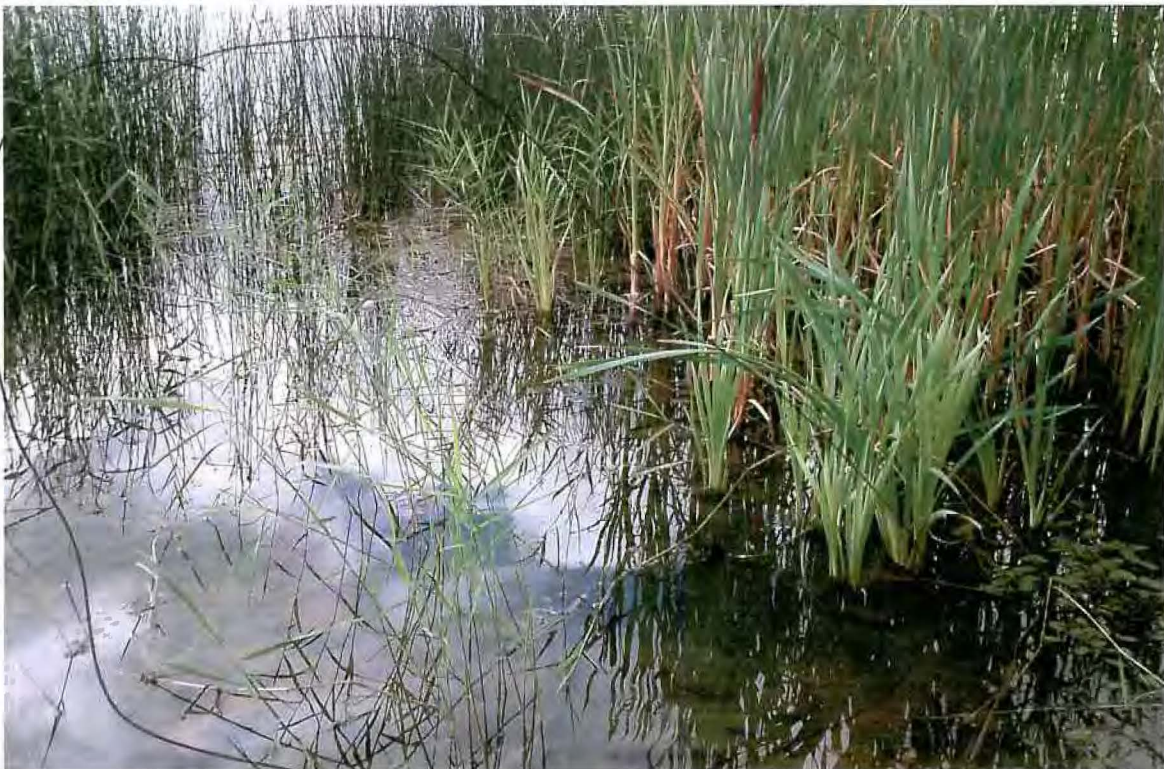
PHRAG Patch in water

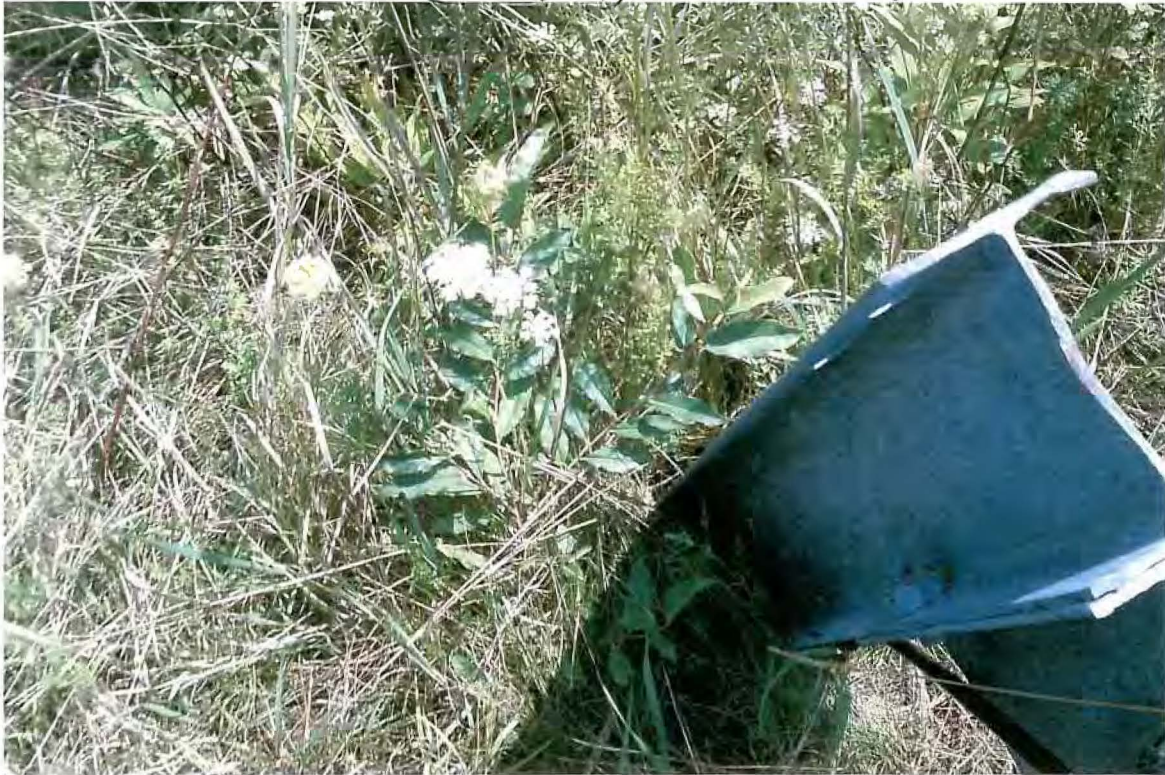
Russian Olive (stump growth treated)

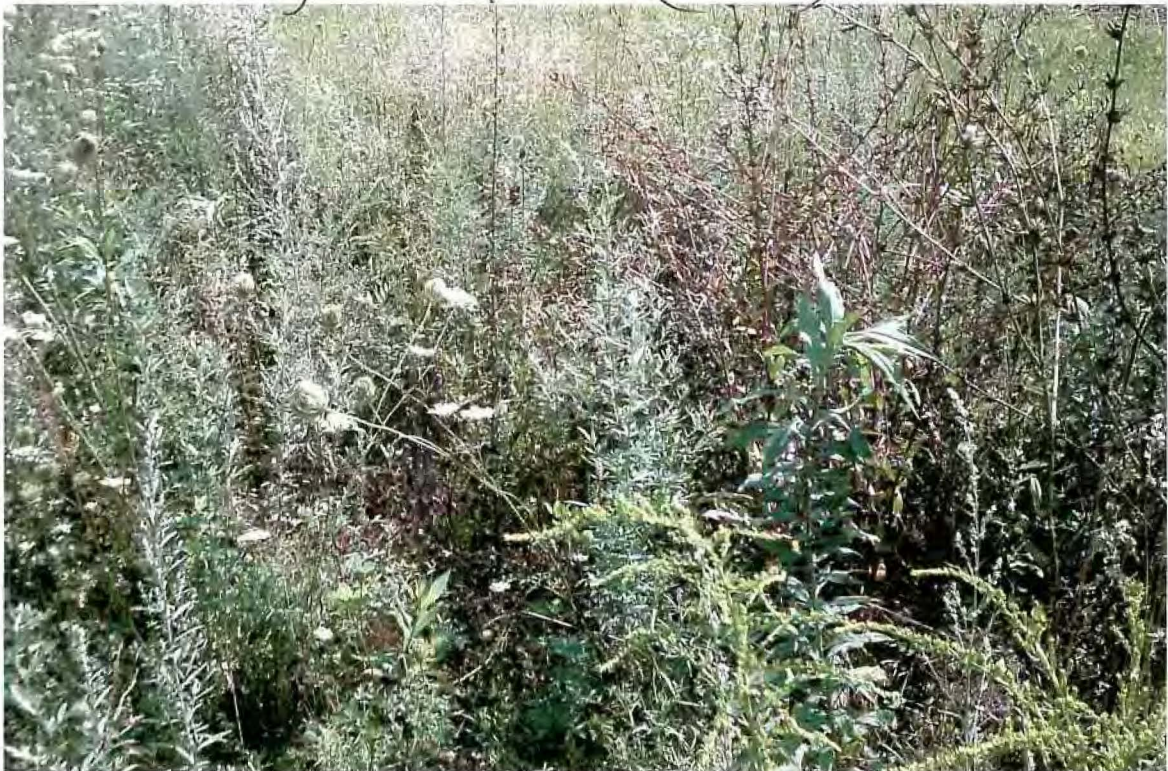
Mugwort Patch (SW)

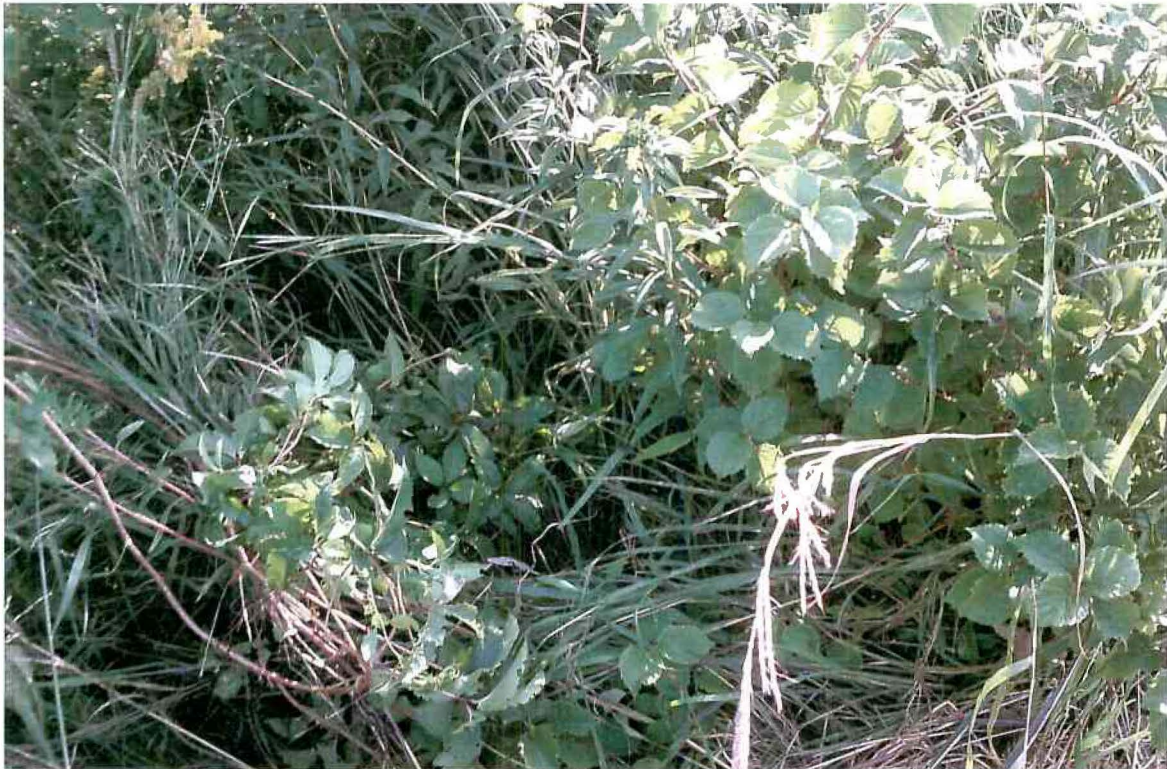
Virginia Creeper & Grapevine Removed from plants

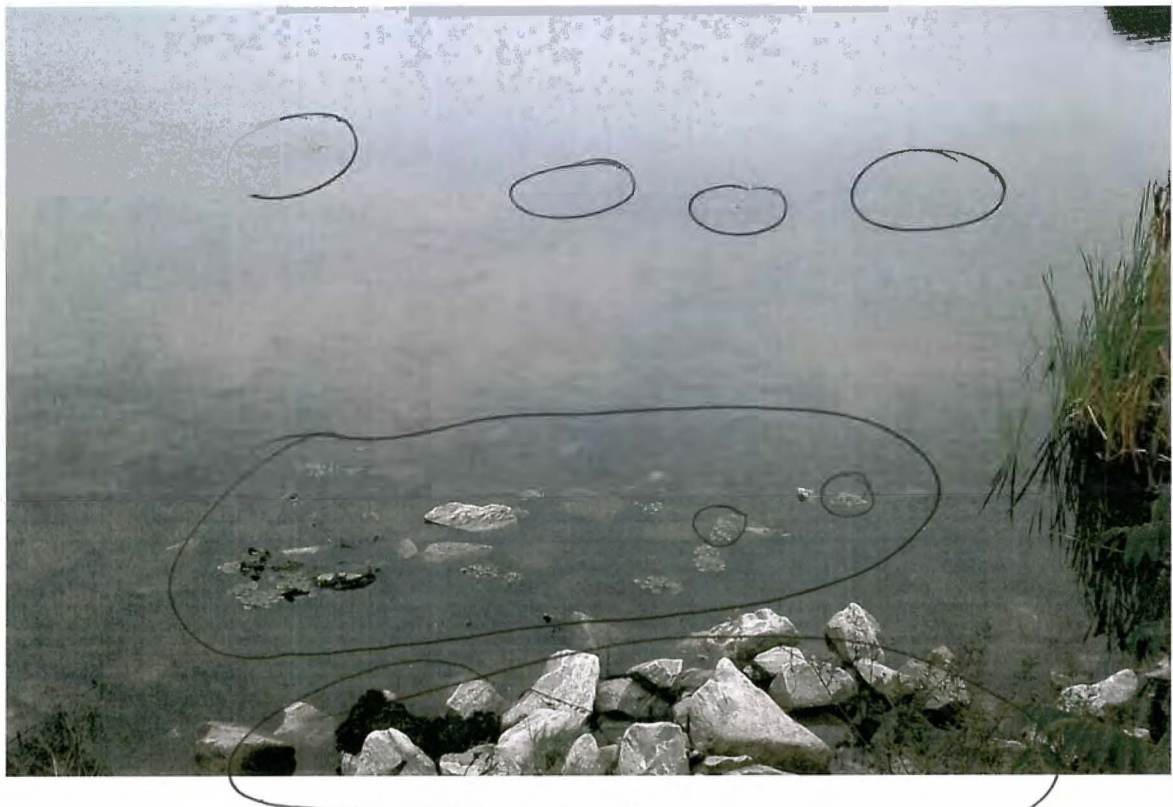
Water Chestnut

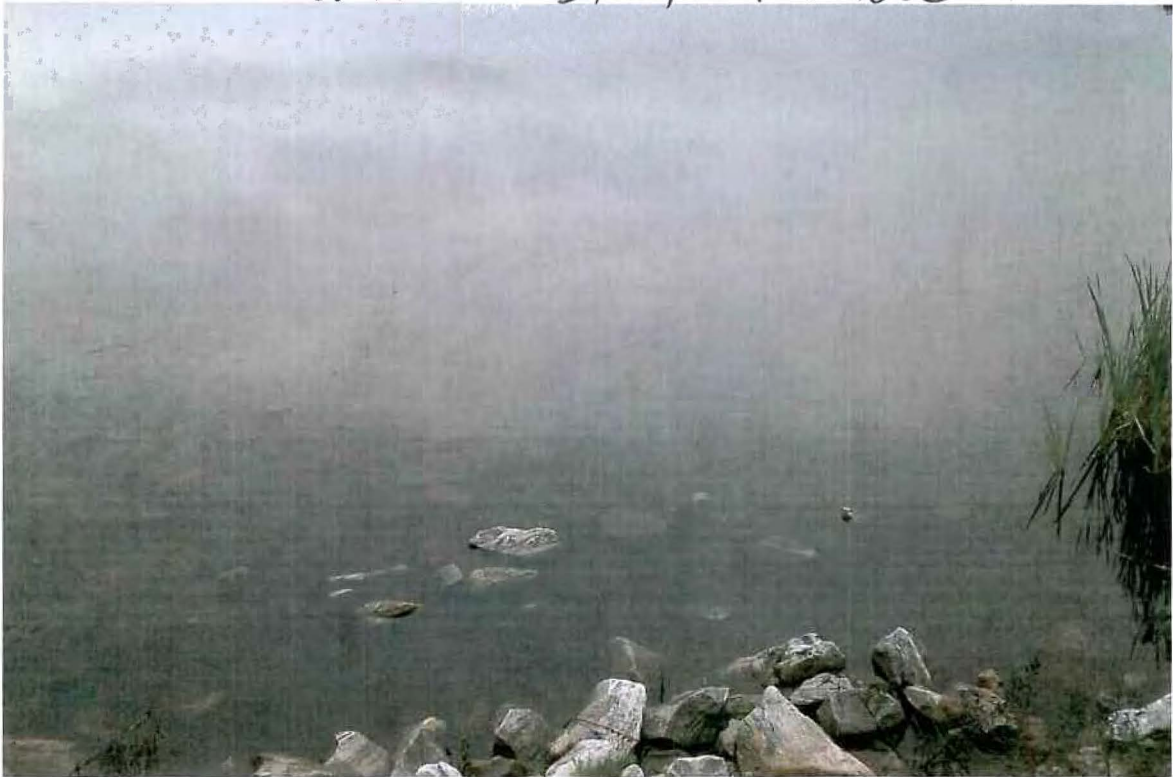
Front of Drainage Pipe

Water Chestnut Removed

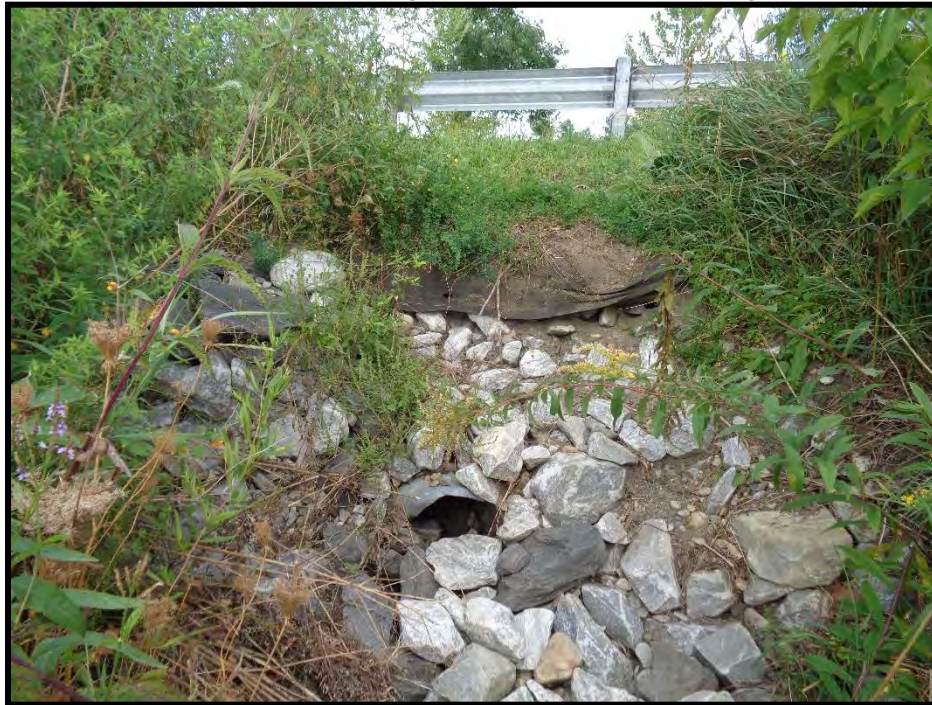
- No significant erosion was observed, and no conditions were observed that could impair discharges from the outfalls.  
 - Displacement of armor stone and exposure of geotextile fabric was observed at SL-OF-09.

**Photograph 1: Displaced armor stone and exposed geotextile at SL-OF-09 (looking up-bank).**

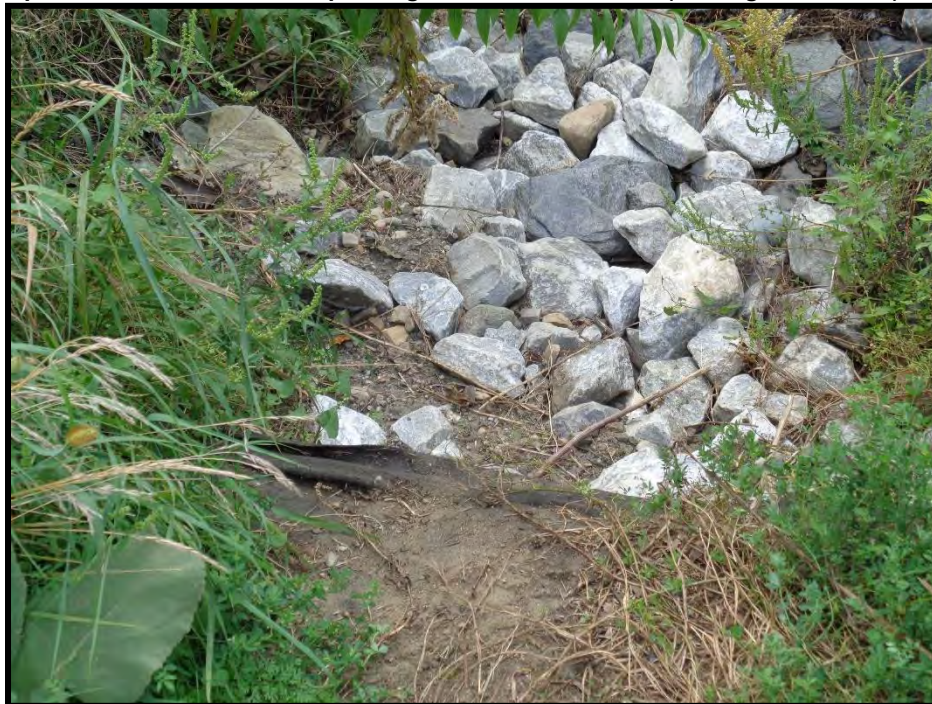
**Photograph 2: Displaced armor stone and exposed geotextile at SL-OF-09 (looking down-bank).**
